Sulphate Attack

Project:
Sulphate Attack
Location:
Various
Consulting Engineer:
Alan Wood & Partners

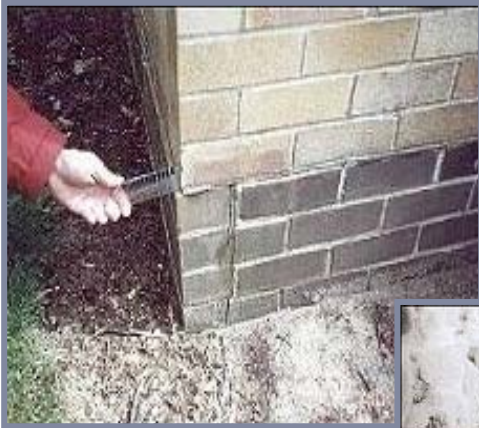
The expansive force of the chemical reaction can displace the external and sleeper walls leading to the opening of skirting board joints, the bouncing of timber floors, cracking and displacement of brickwork as the above photo and the disruption of concrete floors and sub-floors. It can take anything for 10 to 20 years for the physical defects mentioned above to manifest themselves.

With sulphate attack the correct solution is to remove all defective concrete and contaminated hardcore and replace both. This is very disruptive and costs can be substantial. Sulphate attack is not normally covered by buildings insurance as it tends to be excluded by means of a clause exempting all forms of chemical attack. However, where it is possible to prove that an escape of water such as a cracked drain has triggered the reaction the insurance claim may be successful.

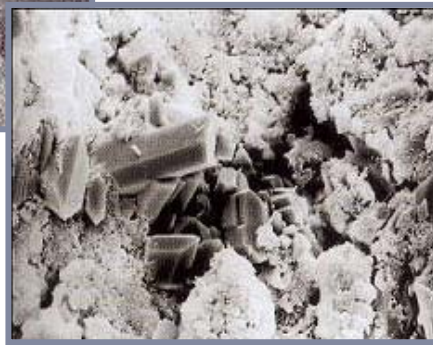
Microscopic view of Sulphate crystals in concrete

Sulphate attack is a chemical reaction, affecting the concrete in the floor construction of properties. Sulphates present in contaminated hardcore, together with a source of moisture it reacts with the cement in the concrete causing it to expand and crack.
