# Sulphate Attack

**Project:**  
Sulphate Attack  
**Location:**  
Various  
**Consulting Engineer:**  
Alan Wood & Partners

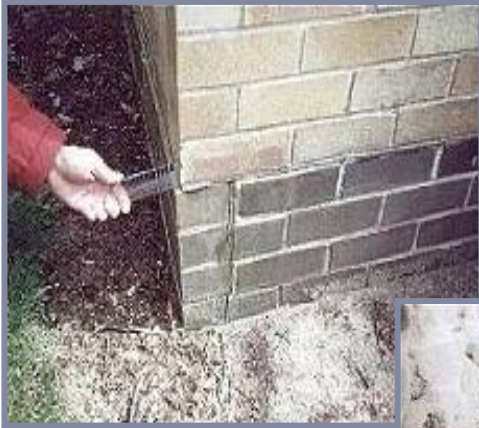
The expansive force of the chemical reaction can displace the external and sleeper walls leading to the opening of skirting board joints, the bouncing of timber floors, cracking and displacement of brickwork as the above photo and the disruption of concrete floors and sub-floors. It can take anything for 10 to 20 years for the physical defects mentioned above to manifest themselves.

Sulphate attack is a chemical reaction, affecting the concrete in the floor construction of properties. Sulphates present in contaminated hardcore, together with a source of moisture it reacts with the cement in the concrete causing it to expand and crack.

With sulphate attack the correct solution is to remove all defective concrete and contaminated hardcore and replace both. This is very disruptive and costs can be substantial. Sulphate attack is not normally covered by buildings insurance as it tends to be excluded by means of a clause exempting all forms of chemical attack. However, where it is possible to prove that an escape of water such as a cracked drain has triggered the reaction the insurance claim may be successful.

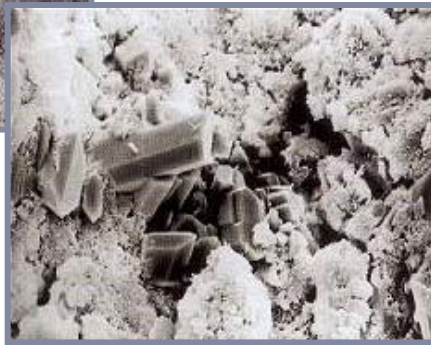
Microscopic view of Sulphate crystals in concrete
