Keadby Jetty - Keadby, Lincolnshire

Jetty Collision Damage

Keadby on the River Trent

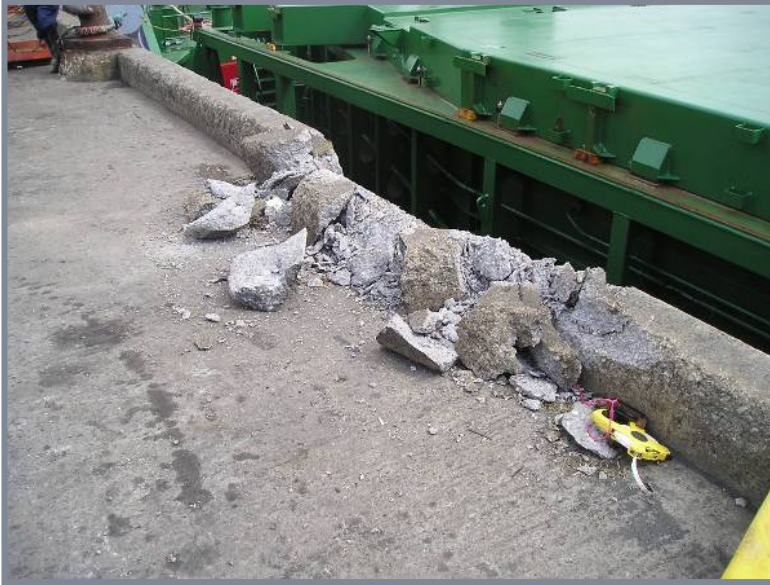
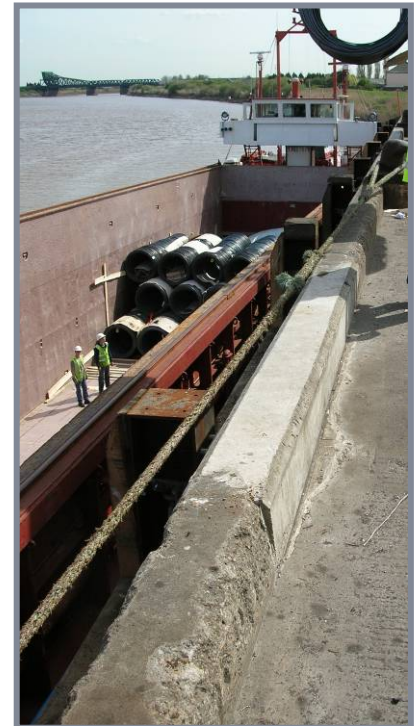
However, one of the large vessels coming in to Keadby failed to turn in time and sailed bow first in to the jetty face.

The jetty survived but the collision did cause extensive damage to the fenders, buckled one of the main deck piles and fractured the concrete plinth on the off-loading deck.

Upon our inspection of the damage Alan Wood and Partners were required to design and procure the repair of the jetty, the works

were to provide new fendering, execute specialist concrete repairs to the damaged concrete and to strengthen the buckled jetty pile.
